FREEDOM YACHTS MAST CRACKING CAUSES AND THE CURE

By
Eric W. Sponberg
Naval Architect

REPAIR OF SURFACE CRACKS IN FREEDOM YACHT MASTS

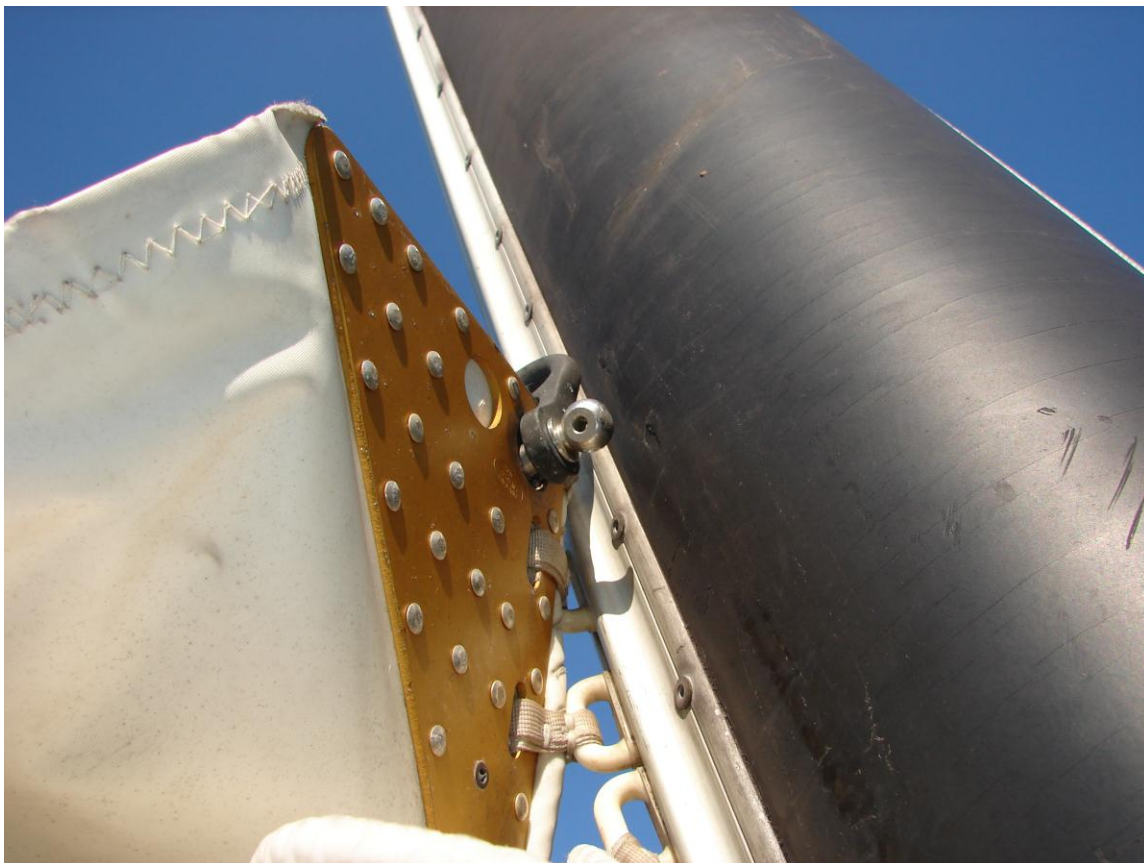
The circumferential cracking occurs over time with the working of the mast. Because there are no cross-fibers through the layers of glass windings, the gelcoat cracks at the boundary between the gelcoat to the fiberglass windings. They start right between individual fibers of the glass windings, and because the gelcoat is a relatively brittle material and at the surface where bending stress is the greatest, the cracks work their way to the outer surface of gelcoat and through the paint. In the vast majority of cases, the cracks don't go the other way—they stop at the surface of the carbon fiber layer underneath. If you stick a knife blade into a normal crack, you will see that it won't go in very far, hardly at all, in fact. So the cracks are not deep and they do not penetrate into the structural carbon fiber below. So a few minor cracks are of no concern and the masts should be just fine.

Photo 1. Minor cracking on a Freedom 39 mast, spacing about an inch apart.

If the cracking looks bad, then the masts should be pulled from the boat, stripped of their hardware, the surface gelcoat ground off down to the outer glass windings layer, and two new layers of fiberglass and epoxy laminated over the mast for a fresh new surface. This is then sanded down smooth, filled, faired, and the masts can be repainted. This cures the problem entirely.

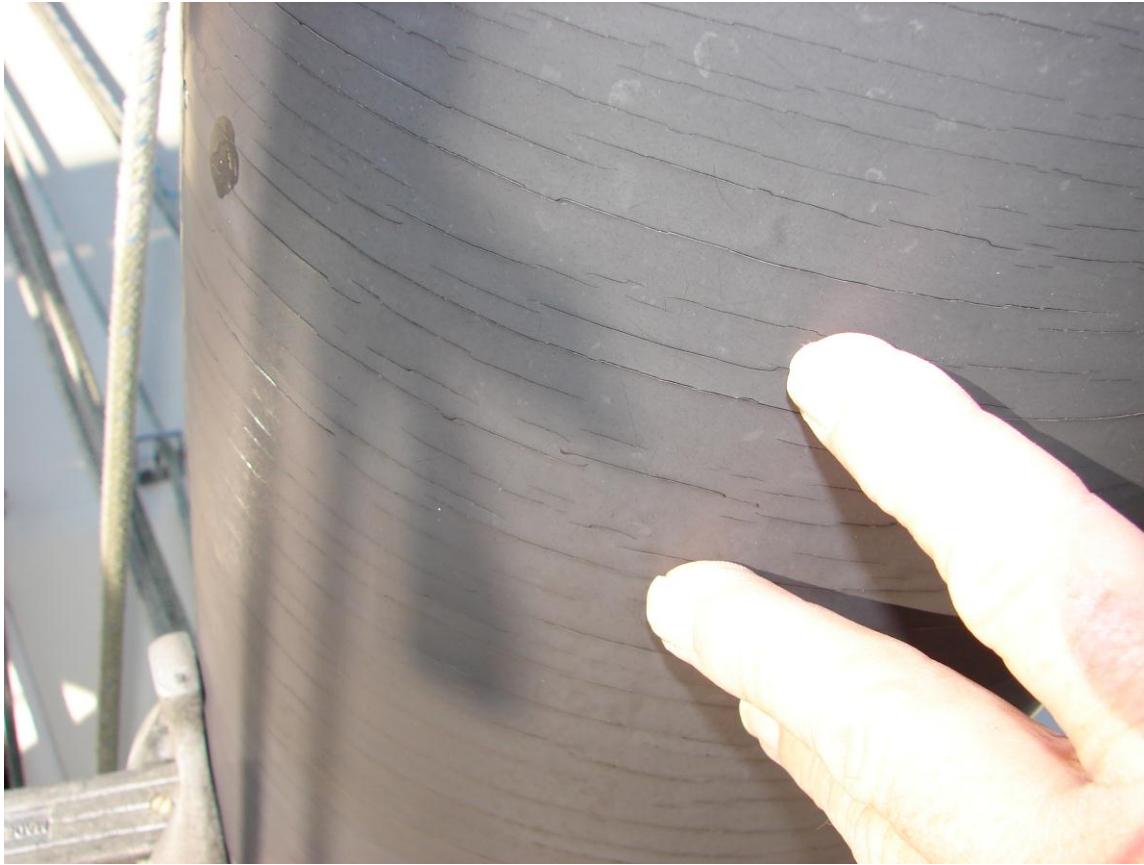
Photo 2. Same Freedom 39 mast near the gooseneck where the bending is more and so the cracks are more numerous and more closely spaced.

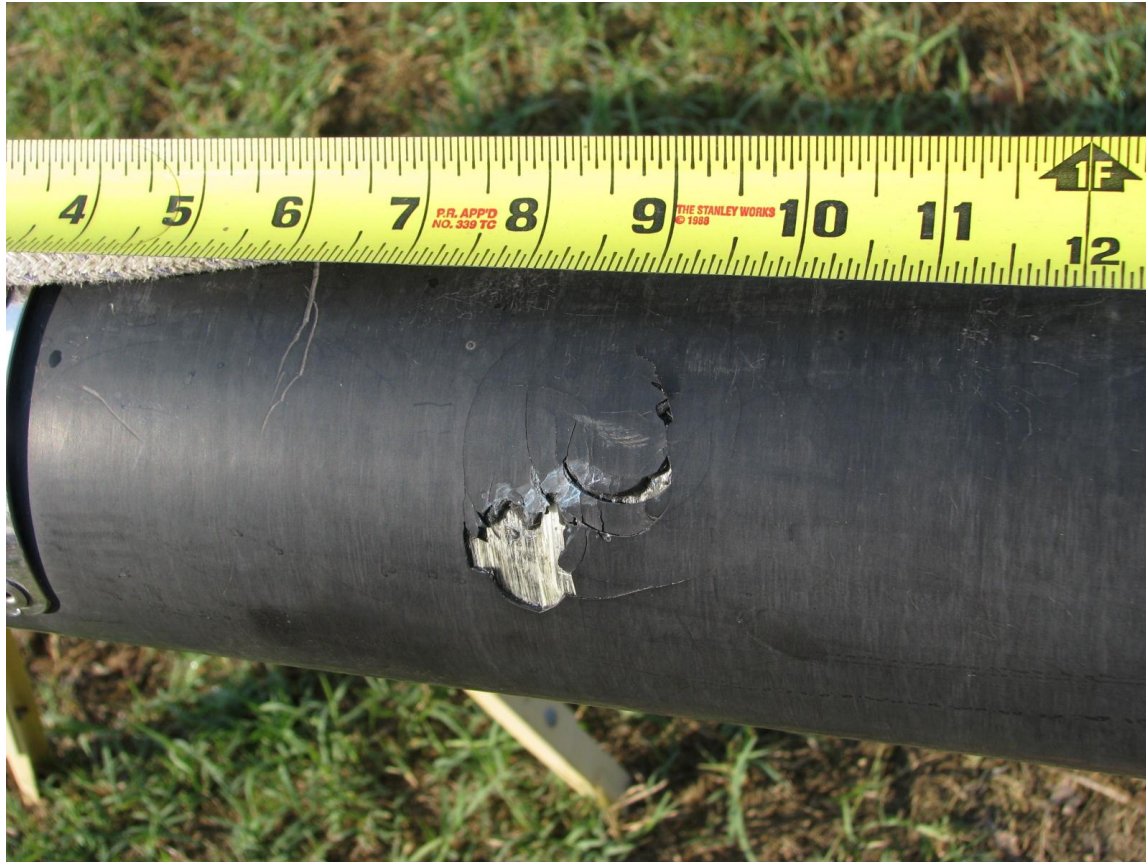
In Photo 3 on the next page, a Freedom 21 mast was accidentally dropped during its stepping onto the boat, and where the mast hit the deck edge, the gelcoat was chipped and damaged. I show this photo only to show what the surface looks like under the gelcoat, and how thick the gelcoat can be. However, I have seen instances in which the masts have been heavily used or not well maintained, and the cracking is quite severe and looks pretty deep. The gelcoat can be chipped off with a knife, similar to how this looks.

Photo 3. Impact damage on a Freedom 21 mast, showing gelcoat and underlying glass.

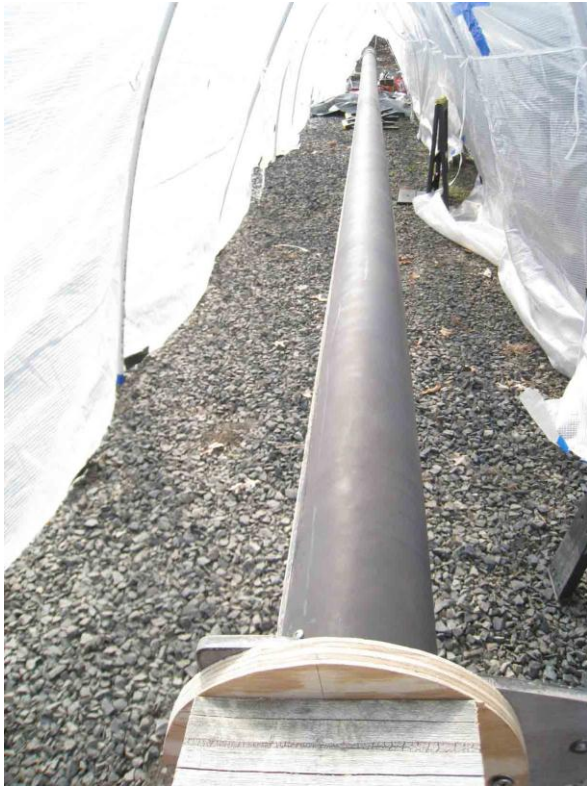
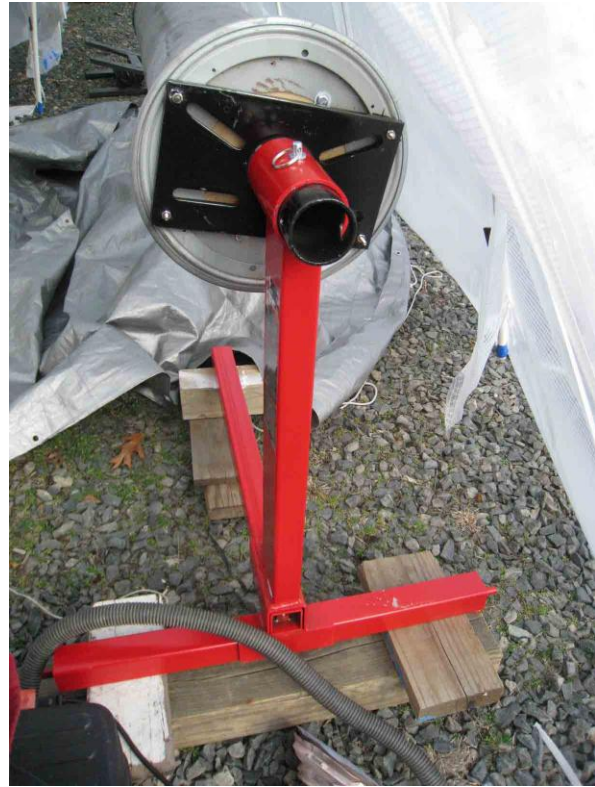
Photos 4 & 5. A fore mast set up horizontally under a temporary tent, supported by an engine repair crane.

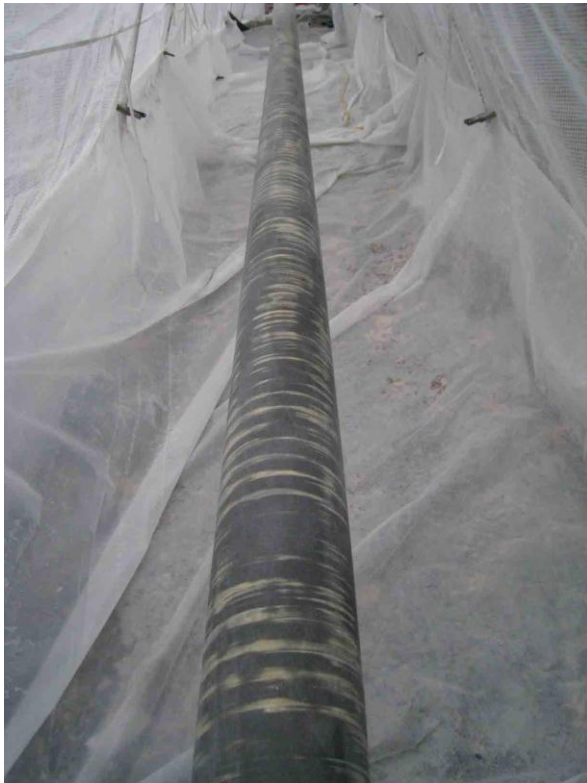
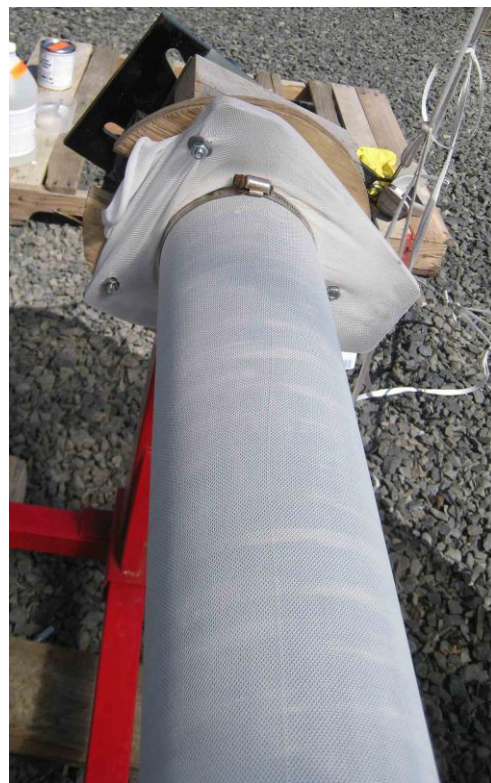
Photos 6 & 7. The mast ground down through most of the gelcoat to the glass, but not all the way through. The glass sock put on. This owner used a tube fabric from Giant Leap Rocketry: http://giantleaprocketry.com/products/components_composites.aspx.

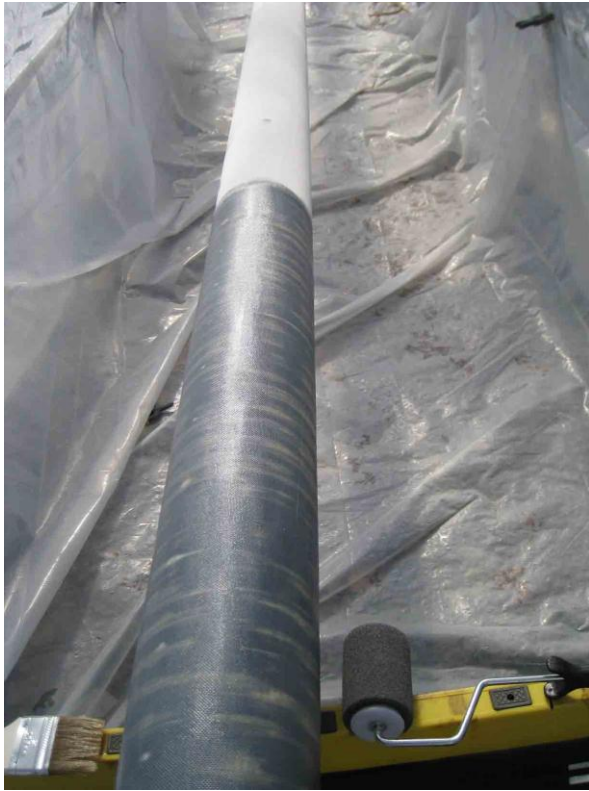
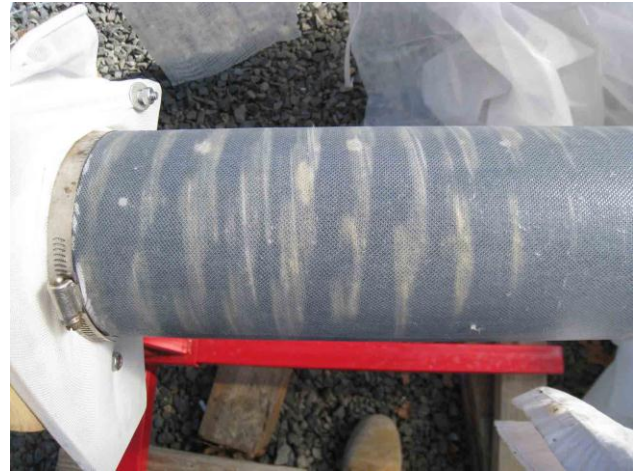
Photos 8 & 9. Wetting out the glass with epoxy, with a close-up of the lay-up. This owner bought epoxy from Progressive Composites: <http://www.epoxyproducts.com/>.

If using the fiberglass sock, the fabric is put on dry and wet out with resin, one layer at a time. Let each layer cure. If using cloth, either as tape or as broad good, the mast may be wet out first and the dry fabric wound on, wetting it out again as it goes onto the mast. After the first layer of fiberglass is on, and if the resulting surface is still relatively smooth and still in green cure (after exotherm but not fully hardened) the second layer may be laminated on right away. If the first layer is fully cured (overnight or after at least 24 hours), then the first new glass surface should be sanded with coarse grit sandpaper before putting on the second layer. After the second layer is on and cured, the mast may be sanded entirely again, the surface filled and faired, and then it may be primed and painted with any good quality marine paint system. Two-part polyurethane paints are recommended, as are lighter colors rather than darker colors.

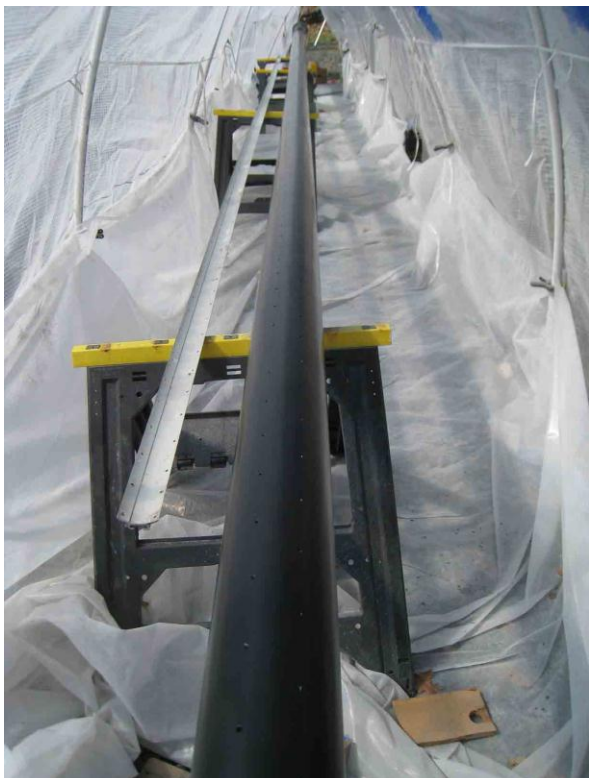
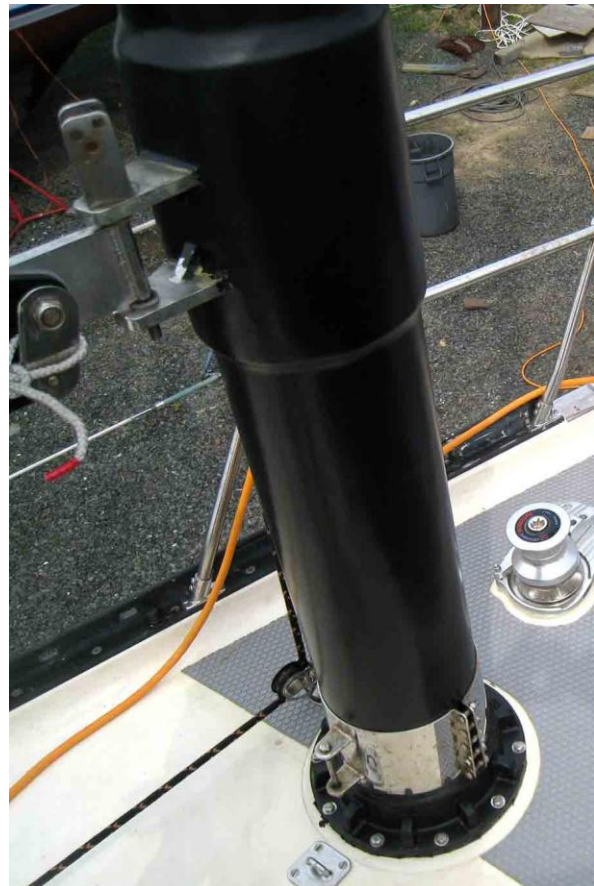
Photos 10 & 11. Painting and installation back on board. The paint was a moisture-cured polyurethane from: <http://www.por15.com/CHASSIS-COAT-BLACK/productinfo/CHG/>.

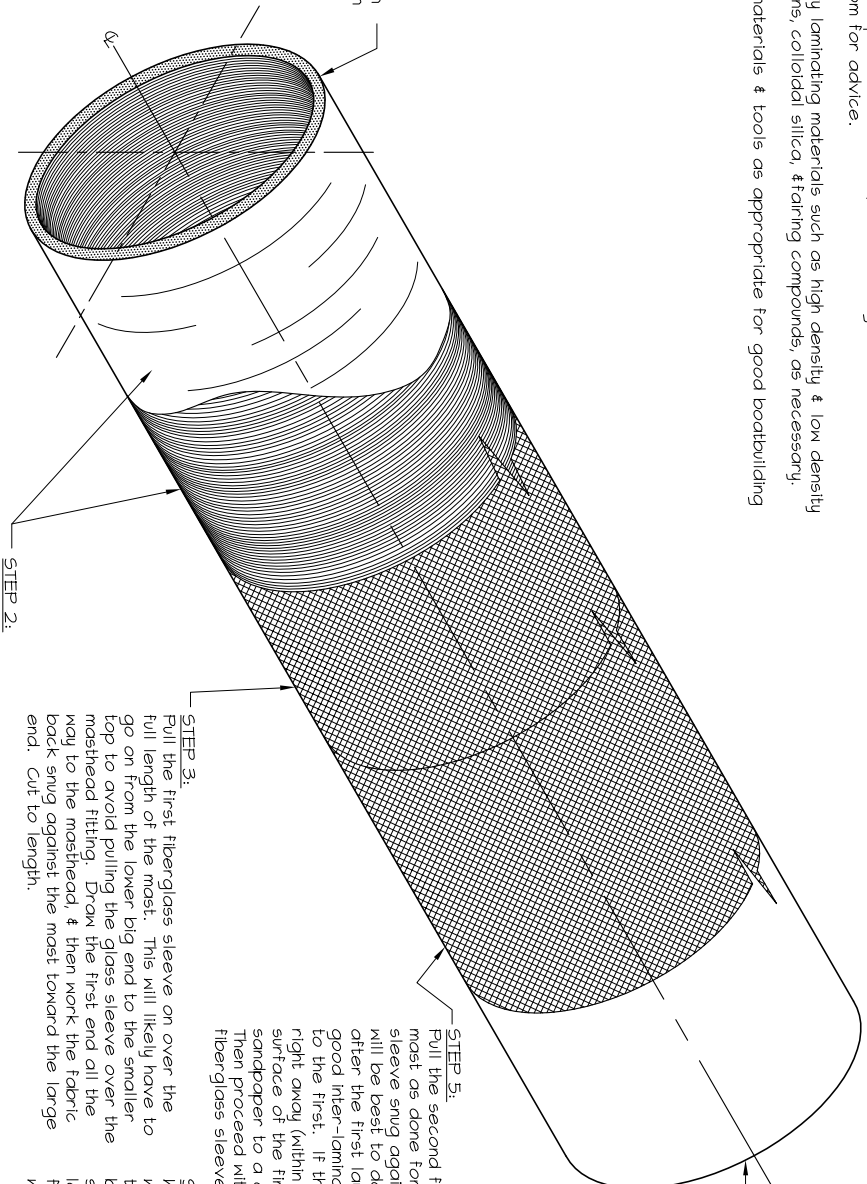
GENERAL NOTE:
1. The carbon fiber Freedom Yacht masts built by Tillotson-Pearson Inc. (TPI) have a tendency to crack in the surface in the circumferential direction. Many times, these cracks are minor, very thin & tight, & can be left alone—for awhile. However, they can get worse over time, opening up & curling at the edges, even to the point that the gelcoat underneath the paint can chip off. When that happens, the masts should be repaired.

3. The masts must be removed from the boat & brought inside a protected area under a roof & out of the weather. Support the mast on horses horizontally so that it is at a comfortable working level, about waist high. The mast is to be stripped of its outside coating down to the bare fiberglass windings & relaminated with fiberglass & epoxy resin. Follow Steps 1 through 6 here.

After paint prep, spray paint the mast to the owner's choice of color. Oyster White is a popular choice. Paint the mast according to paint manufacturer's directions for high-quality finish. Let cure. Polish out any blemishes as necessary. Once finished, proceed with reinstallation of sail track & other hardware.

Remove any hardware from the mast. Fill the fastener holes with high-density epoxy adhesive & let cure. Any other holes or openings that are to be preserved, such as the locking bolt holes at the bottom of the mast, should be filled with bee's wax or children's clay & screeded over or trimmed flush. The new glass sleeves will be laminated over these holes, but they can be drilled out afterwards when the laminating is done.

Grind off all the paint & underlying gelcoat until the glass hoop windings underneath are exposed. Do NOT grind through the hoop windings which would expose the carbon fiber. The original windings provide a sound base to which the new glass sleeves are to be laminated. Sand the surface of the glass windings smooth so that it is free of snags. Some epoxy resin can be coated over bad snag areas. Let these areas cure & sand again before proceeding.

Pull the first fiberglass sleeve on over the full length of the mast. This will likely have to go on from the lower big end to the smaller top to avoid pulling the glass sleeve over the masthead fitting. Draw the first end all the way to the masthead, & then work the fabric back snug against the mast toward the large end. Cut to length.

Met the entire surface of the glass sleeve with Pro-Set epoxy resin, trying to measure the resin to approximately 50% resin content by weight. That is, the weight of the resin should equal the weight of the glass when the laminating is complete & cured. Roll out the fiberglass with resin & spread off excess well. Let this layer cure.

Pull the second fiberglass sleeve on over the mast as done for the first layer. Work the sleeve snug against the mast as before. It will be best to do this as soon as possible after the first layer has cooled to get a good inter-laminar bond of the second layer to the first. If the second layer cannot go on right away (within 24 hours), sand down the surface of the first layer well with 60-grit sandpaper to a generously rough surface. Then proceed with pulling on the second layer fiberglass sleeve.
