# A *white* sail for Edmond Dantes

Making a new junksail, then rigging and test-sailing it in the summer of 2012

## Part two

### Rigging and testing the sail

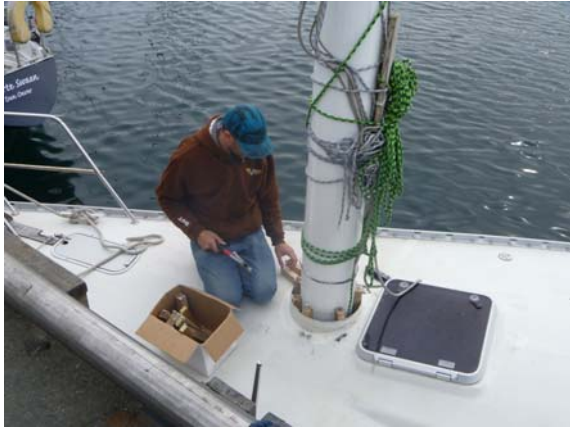
**15:29, time for installing the wedges...**

The mast is made from a spruce tree, dug out to 20% wall thickness and just painted. Diameter 25cm at partners. Edmond Dantes was still a “black ship” with no electricity at this point, but luckily the 2-pot Volvo could easily be hand-started.

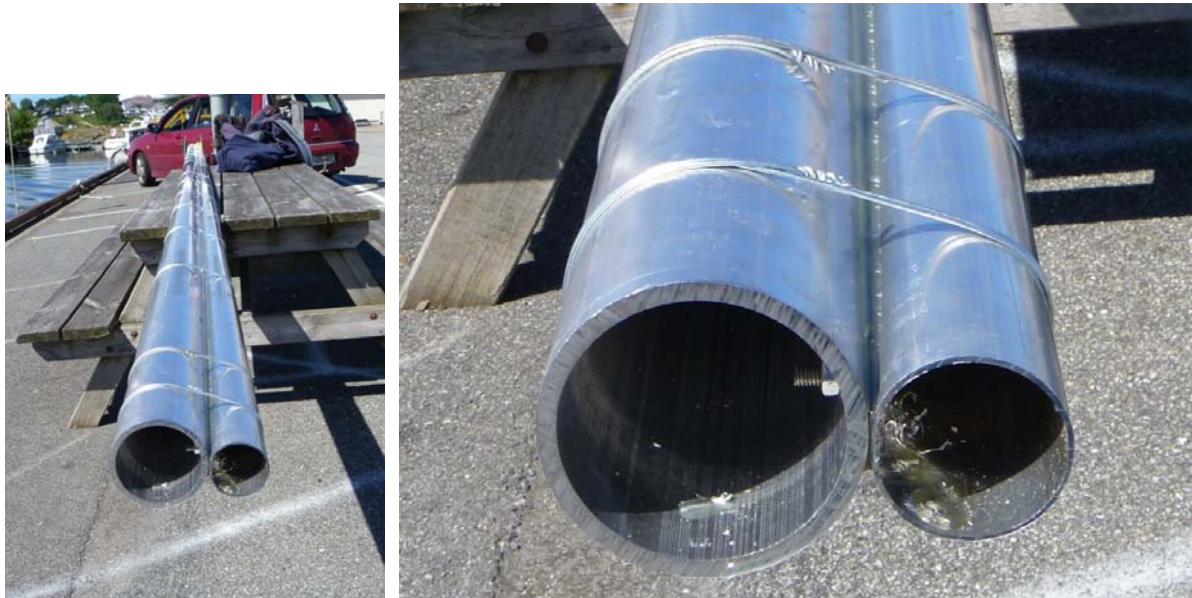
The yard; one 80mm plus one 50mm tube tied, glued and bolted together..

The yard was meant to be of the welded, braced type similar to Johanna's, but with the main tube beefed up from 65 to 80mm. Unfortunately the welding shop was too busy to do it before the summer holidays, so we decided to construct a makeshift yard of the tubes instead. We tied the two tubes together, at intervals of about 40cm, with 1.5mm galvanised steel wire. In addition the groove between the tubes was filled with a thin string of epoxy. Then, at both ends the tubes were bolted together to take the sheer forces which effectively turned the two tubes into one beam. Finally we covered the wires with sports tape.

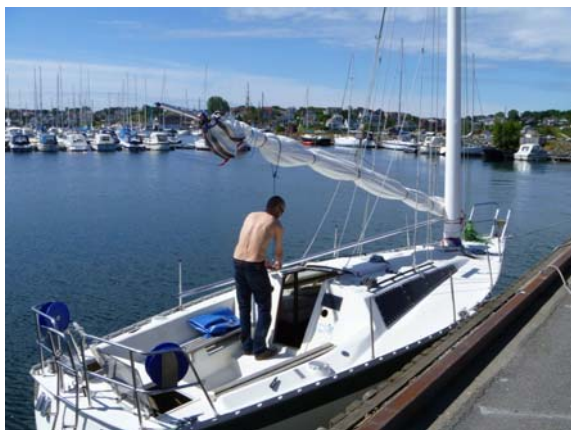
.. the pre-assembled sail bundle installed...

The pre-assembled sail bundle was brought on board and with the mast lift and tack parrel fitted, the halyard could be used to lift the bundle into position. Then the lazyjacks could be

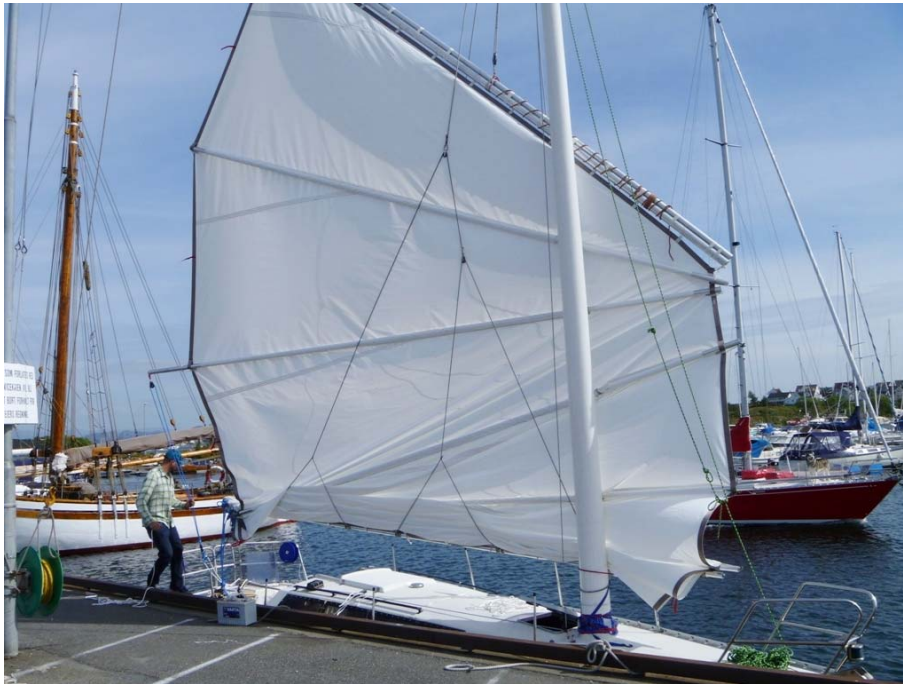
.. 3.5 panels up - looking far from tidy, but still boosting out spirits...

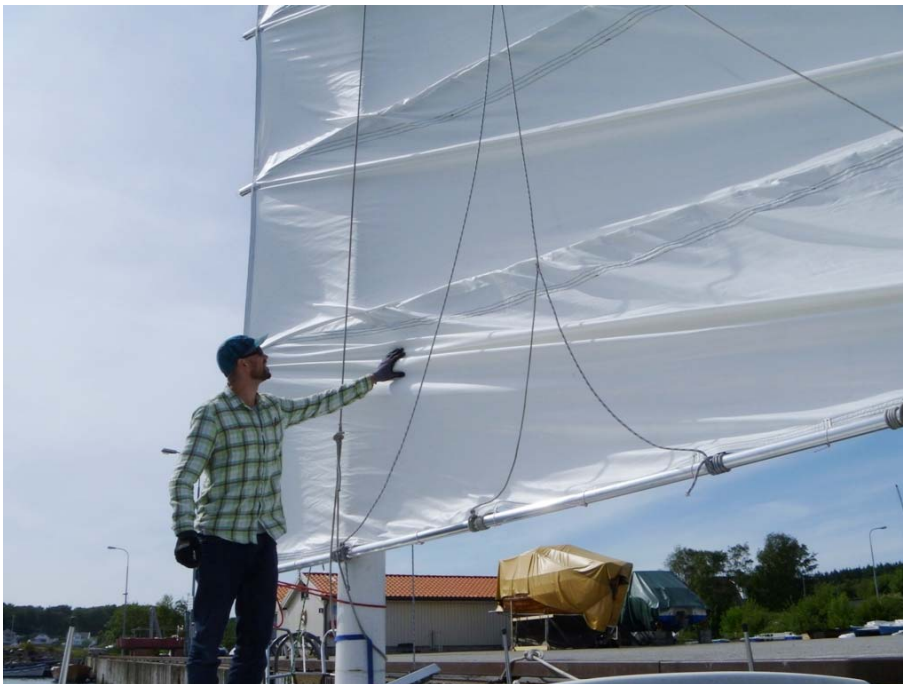
.. the sail fully hoisted for the first time - still much to do...

By the end of that day we had still not fitted fixed parrels like *batten parrels*, *Hong Kong parrels*, nor the *tackline*. The running lines like *lufft hauling parrel* and *yard hauling parrel* were also not fitted yet, but at least the Johanna-type *sheet* was on. The result can be seen with really impressive diagonal creases, stealing the camber from each panel.

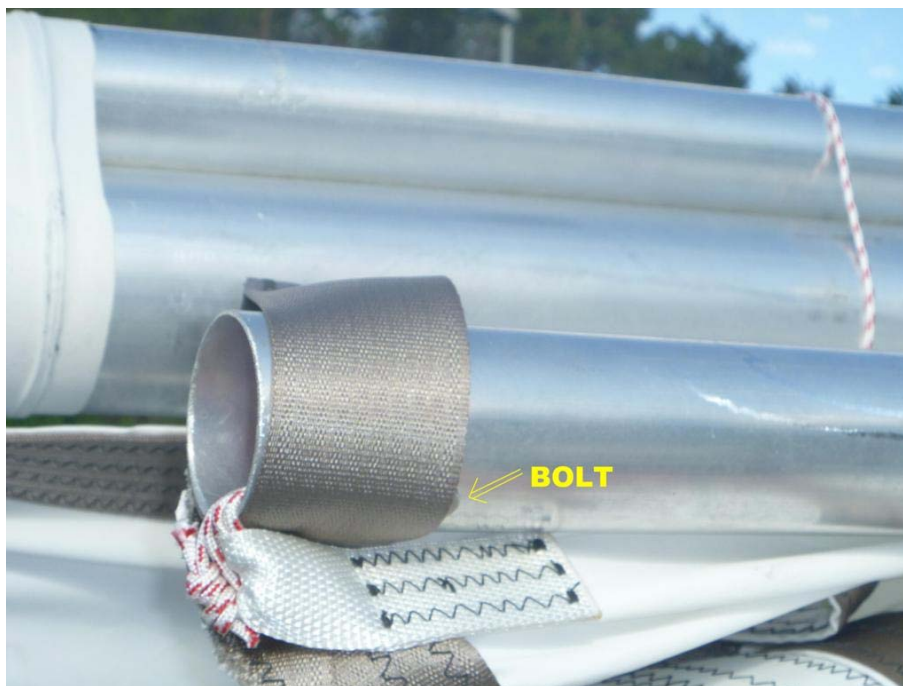
.. leech end of batten 1...

At least I got in one detail this day: On the photo above it can be seen how the sail has been tied to the batten to ensure that the batten will not stick out and catch the sheets when gybing. The white webbing loop is lashed to the bolt passing through the batten. The sheet will also be tied to this bolt on the lower battens - batten 1 has no sheet.

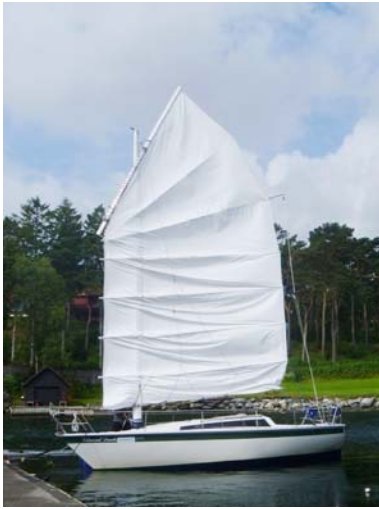
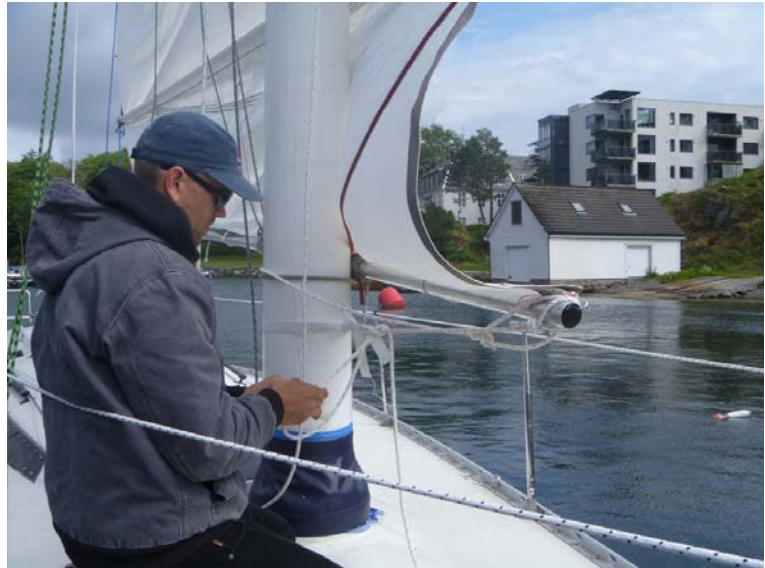
On the left photo the sail has been hoisted with the batten parrels, the luff hauling parrel and yard hauling parrel in place, but probably not adjusted with care. No Hong Kong parrels are fitted yet. There are still some diagonal creases but less than on the first day without any parrels.

On the photo to the right Håvard is adjusting the tack parrel. Woops, the tack parrel should be moved above the mast lift (.. which it was right after this photo was taken...).

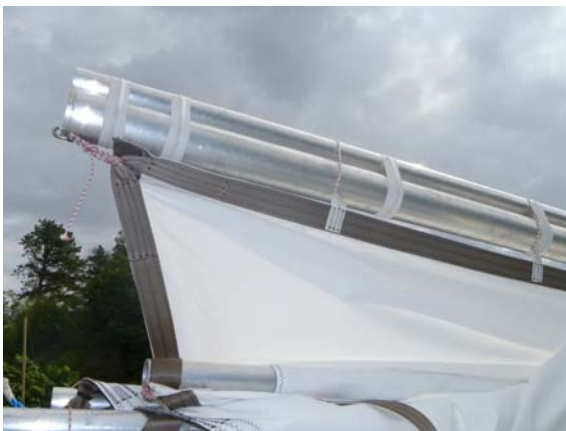
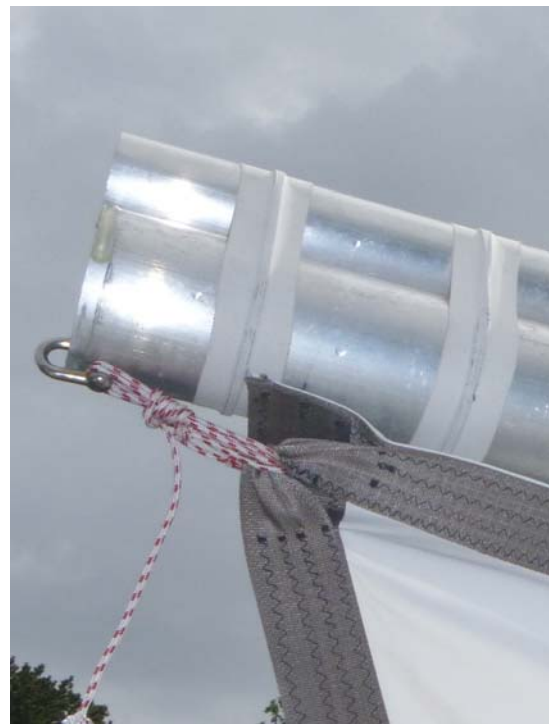
Above shows how the sail was tied to the yard. The enlarged detail (right) shows how a little shackle is fitted to take the peak lacing. This method was used many places, at both ends of the yard and at the luff end of the battens as well.

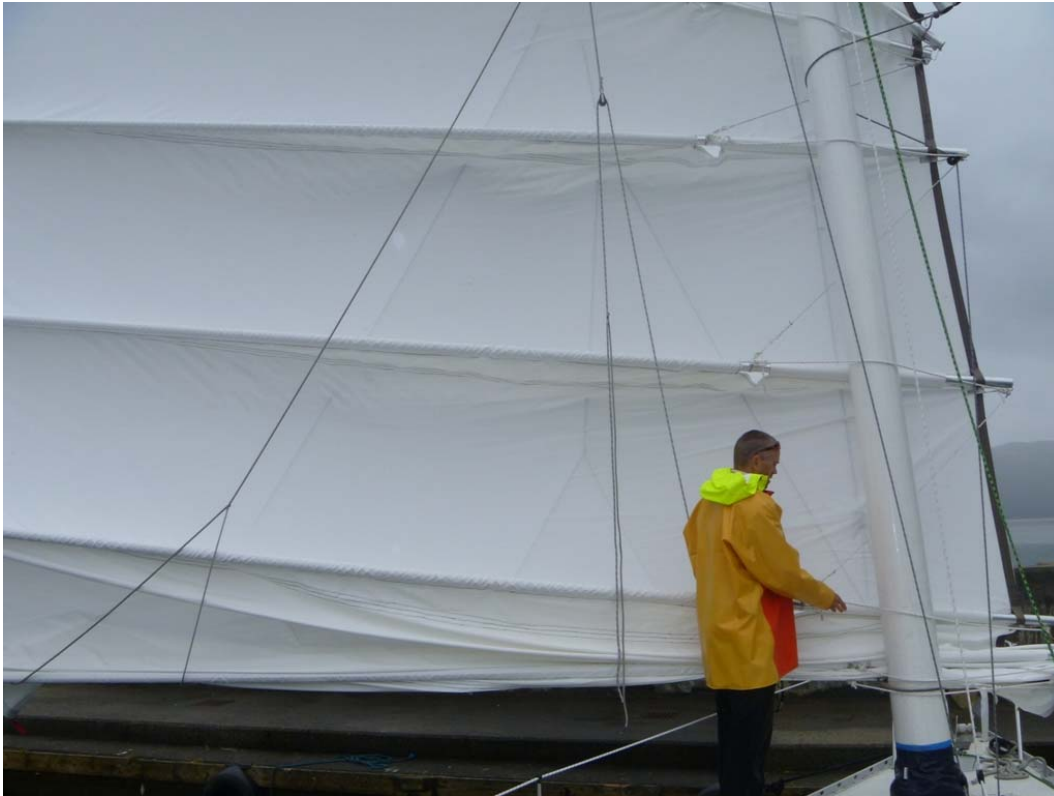
Each HK parrel was adjusted until the diagonal crease disappeared. I later asked and Håvard told me that he did not have to adjust them later. The HK parrels are typical install-and-forget items, as are the batten parrels.

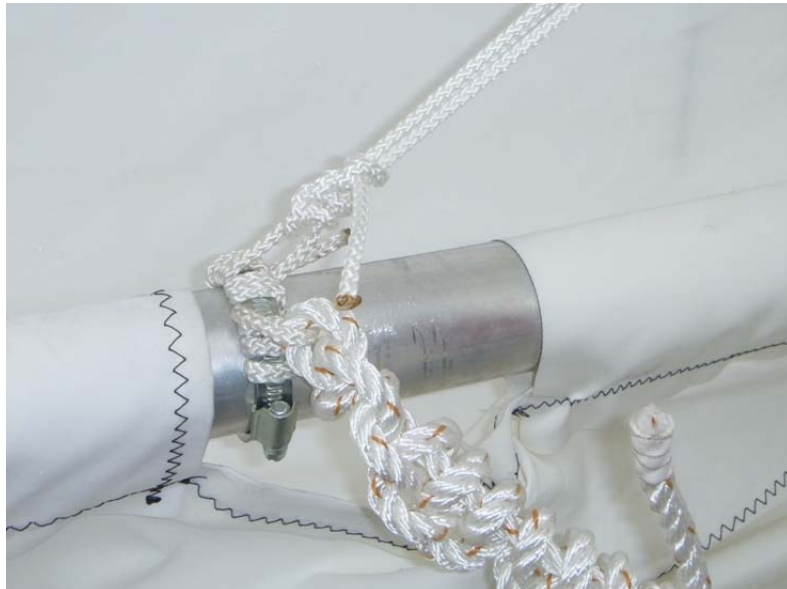
.. attachment of both HK parrels and batten parrel, same as on Johanna's sail....

We used a hoseclip with a line wound around it to form two loops to make a non-slip cleat shared by the Hong Kong parrel and the batten parrel. I now consider splitting it to make the batten parrels shorter and the HK parrels longer on future rigs. On Johanna's rig the batten distance is so short that I seem to get away with the present simple setup.

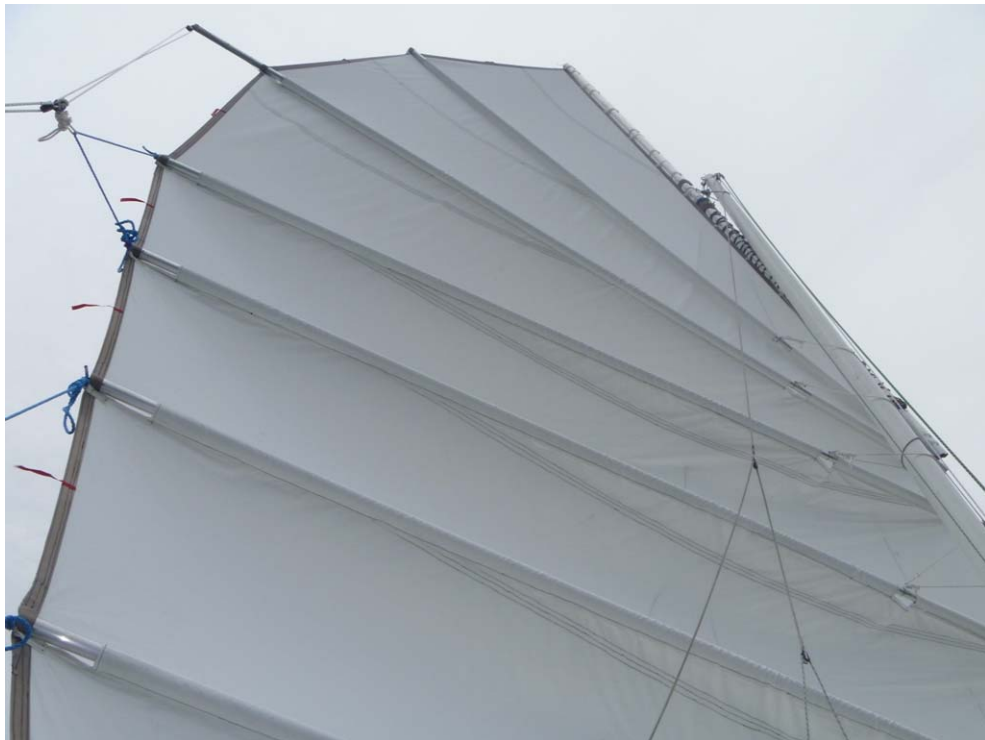
The sail set well. Adjusting the sheetlets seemed to take most time. That is a typical tweeking job on any new JR. The yard was wrapped in lots of old rope to avoid shafe. Telltales have been fitted to the leech.

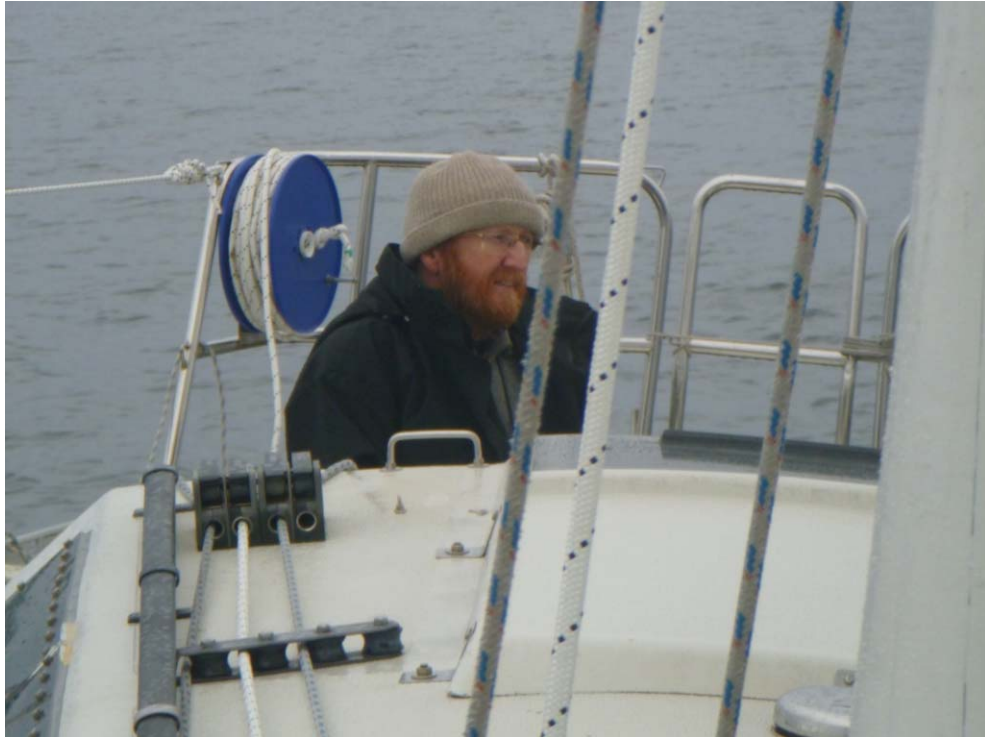
The neat arrangement of halyard and the two running parrels is shown in the photo above. I note that when Håvard reefs or furls the sail, he opens the halyard clutch and eases out the halyard gently with one hand while taking in the slack on the luff hauling parrel with the other. This way he gets perfect control of the much-debated batten stagger as the sail comes down. The use of the clutch on the luff h. parrel simplifies the job a lot. As can be seen, the halyard is stowed on a reel on the pushpit.

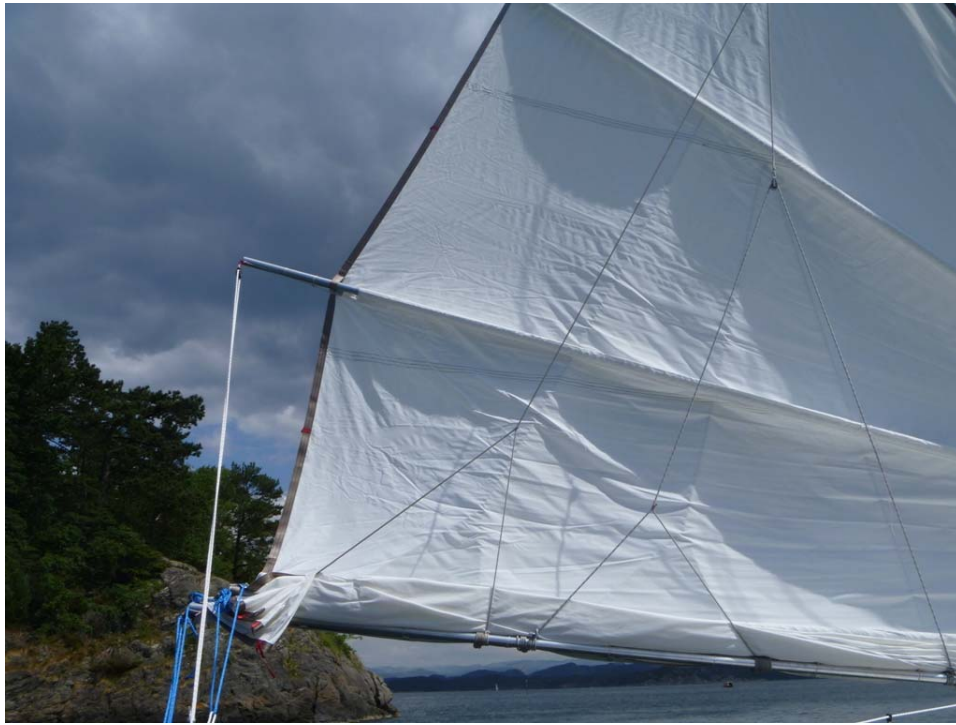
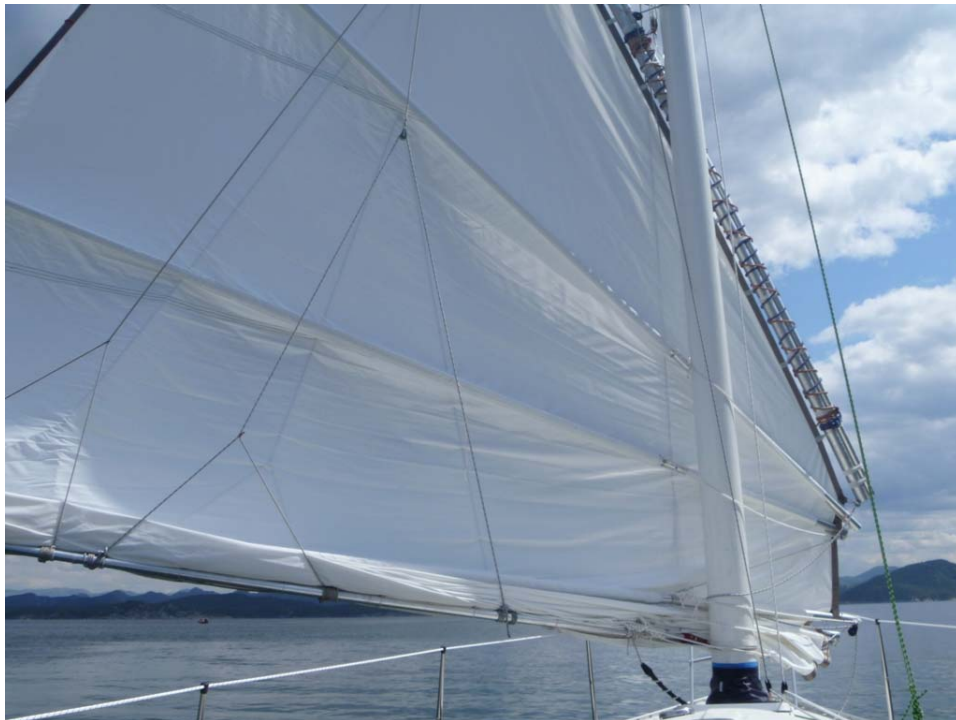
With improved weather three days later, we were able to sneak out of the Ramsvig harbour under 3 panels. This 3-panel, 21m<sup>2</sup> top section has proven to be very effective, both for harbour manoeuvres and when facing strong winds. The lee lazyjack supports the yard and battens so that twist stays tolerable. The tacking angle is wider than with full sail, of course, say 100 - 110° plus, but those 3 panels still take us positively to windward. Don't forget that performance depends of the hull below the rig as well...

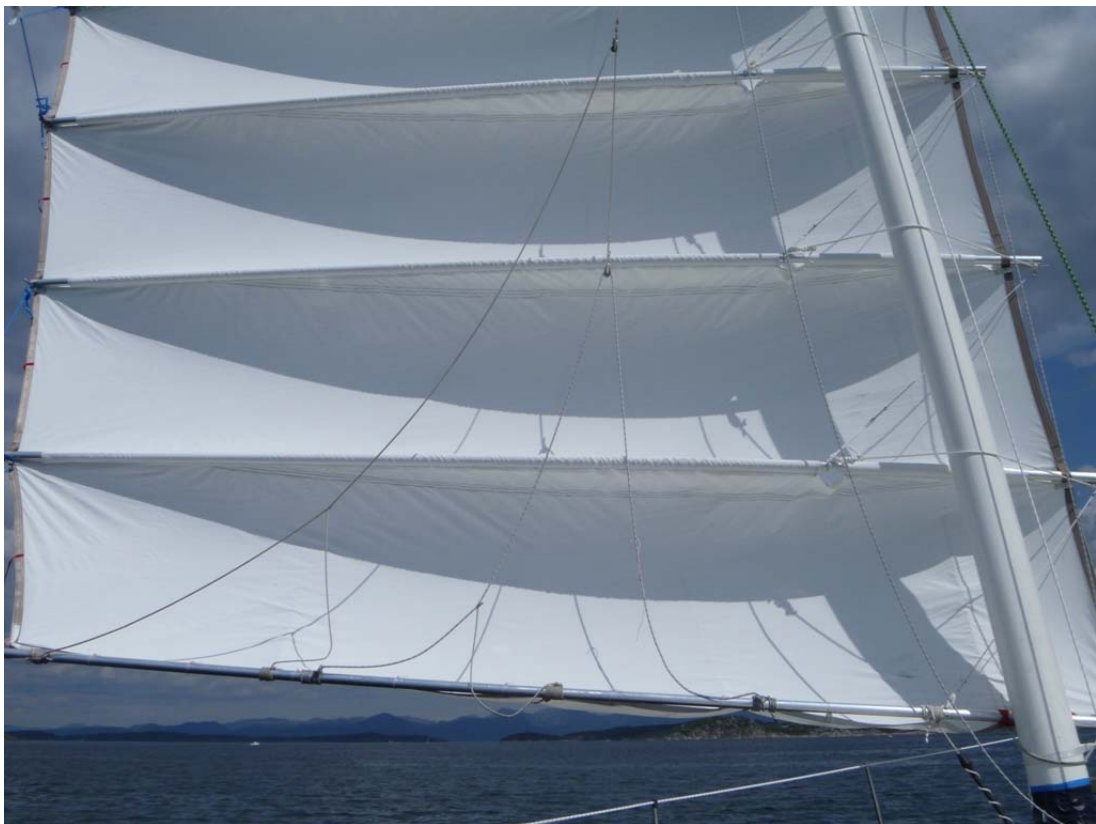
**... thanks to the sunshine, the 9% camber can be spotted without much difficulty...**

As can be seen, the maximum camber point is well forward of the middle and there is no hooked leech. Ordinary, plain *barrel cut method* was used to achieve the camber.

- The use of webbing loops everywhere instead of metal grommets has proven itself on several sails now and I definitely recommend using them.
- It was a lucky decision to increase the camber from 8 to 9%. The extra power in light winds is noticeable and pointing doesn't seem to have suffered. No handling problems.

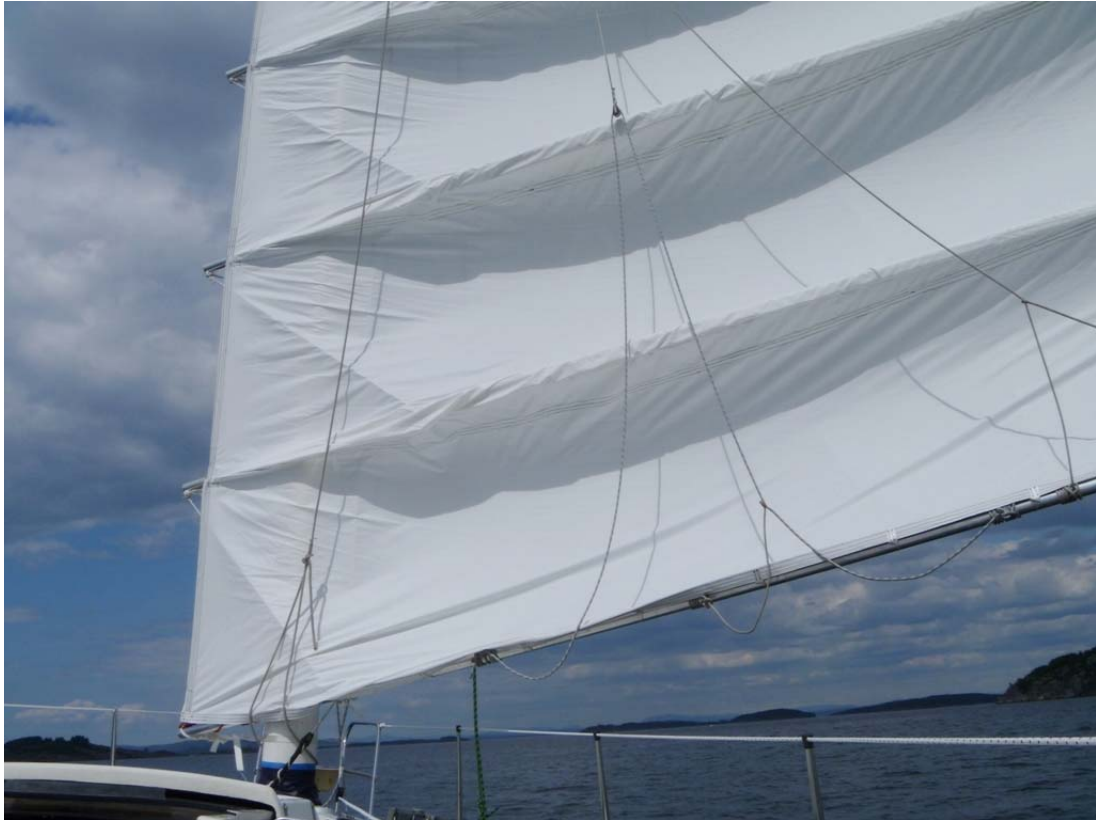
**.. port side, port tack...**

The sail doesn't look perfect from this side with more wrinkles at the battens and the mast and HK parrels trying to spoil the shape. For some reason the sail still feels powerful and close-winded enough and the telltales at the leech are still easy to make fly.

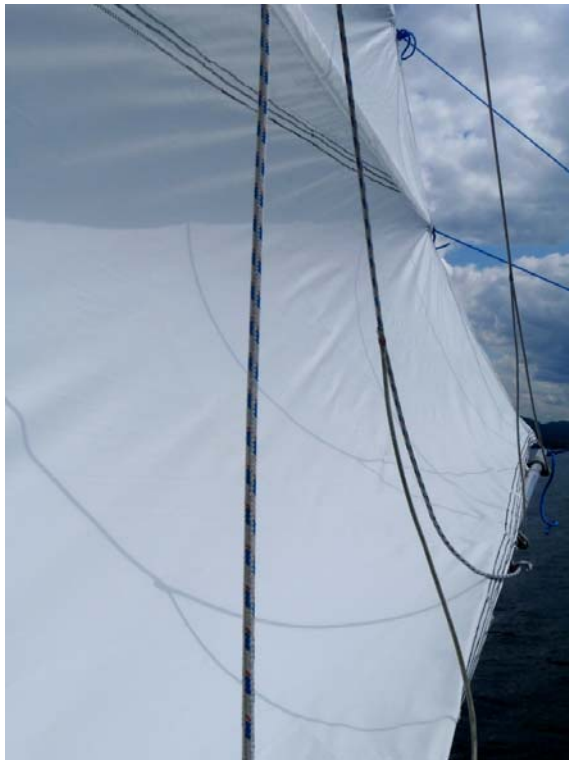
**.. a close-up of the camber in panel 7. I haven't control-measured it, but it surely looks generous...**

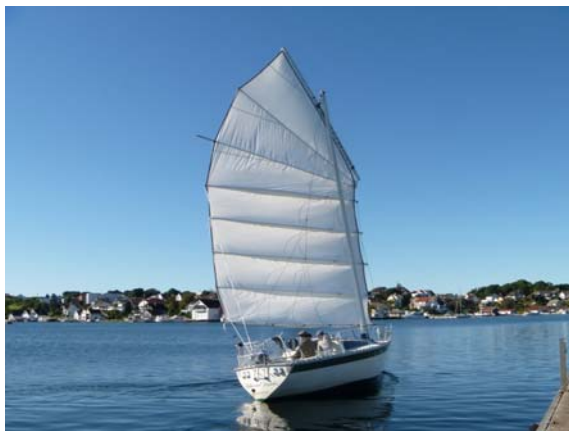
Photo 1, 13:21:55

Håvard soon sorted out the problem, straightened the batten and re-inserted it back to front in the first harbour. Unfortunately, as will be seen in the last batch of photos below, he didn't stretch the sail enough along that batten so there are more wrinkles along it than are strictly needed - even to my tolerant eyes...

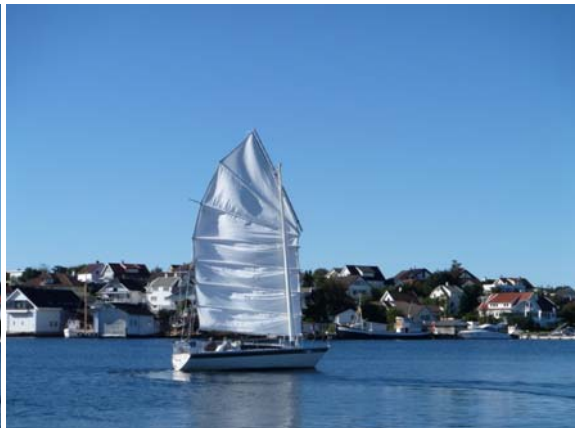
Photo 4, 13:22:24 .. rounding up...

What surprised me when watching ED from the pontoon, was how quick and powerful she was in that light wind. I had this feeling of being in a powerful boat when on board, but she still made my yaw drop when seeing her from the outside. Other boats simply don't handle like that (*.. except Ketil Greve's junk-rigged X-99, Marie G...*).
